HOCKANUM RIVER BASIN  
MANCHESTER, CONNECTICUT

CASE POND UPPER DAM  
CT 00560

PHASE I INSPECTION REPORT  
NATIONAL DAM INSPECTION PROGRAM

MAY 1980

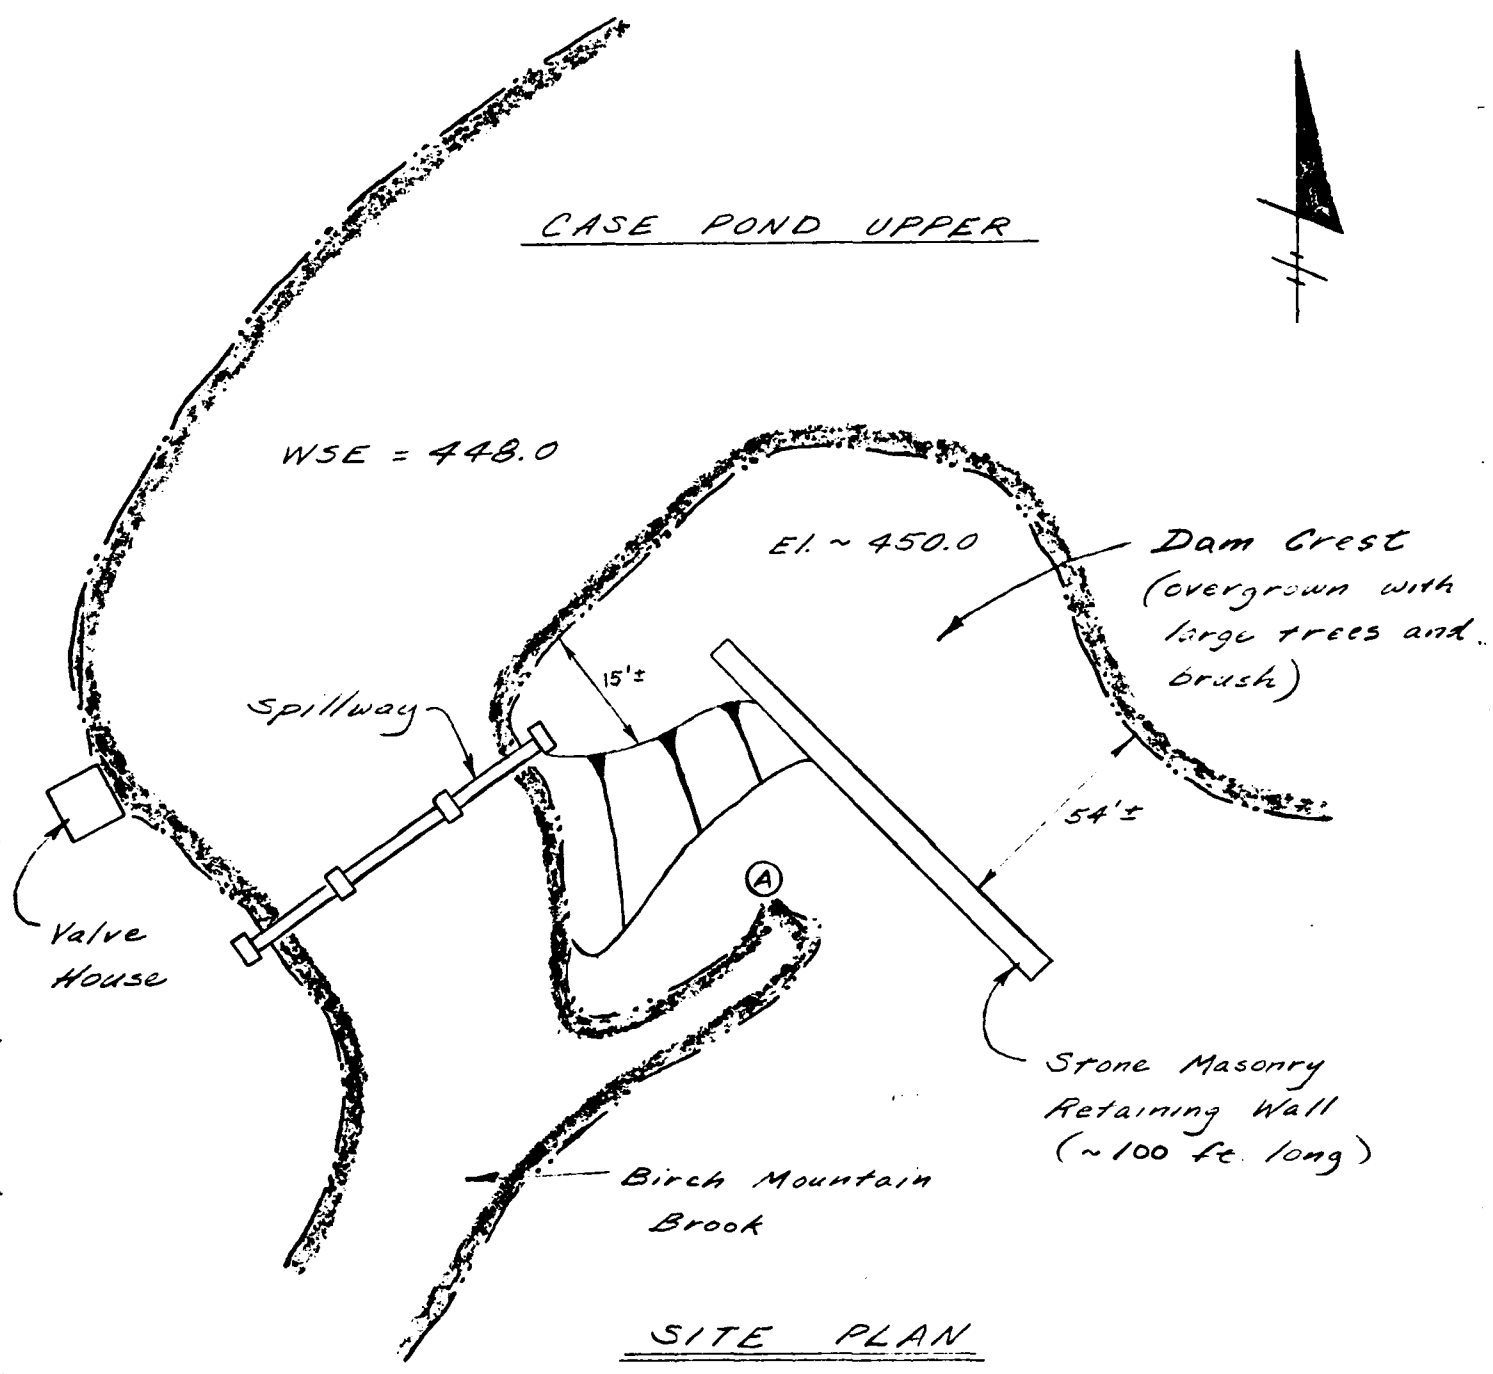
SUBJECT	SHEET	BY	DATE	JOB NO.
Case Pond Upper Dam	B-1	A. H.	3/80	2060-001

(A) Approximate location of "boiling" seepage.
